**MOUNT HIGBY RESERVOIR DAM  
CT. 00140**

**PHASE I INSPECTION REPORT  
NATIONAL DAM INSPECTION PROGRAM**

**FEBRUARY, 1979**

Identification No: CT 00140  
Name of Dam: Mount Higby Reservoir Dam  
Town: Middletown  
County and State: Middlesex County, Connecticut  
Stream: Fall Brook  
Date of Inspection: 8 November 1978

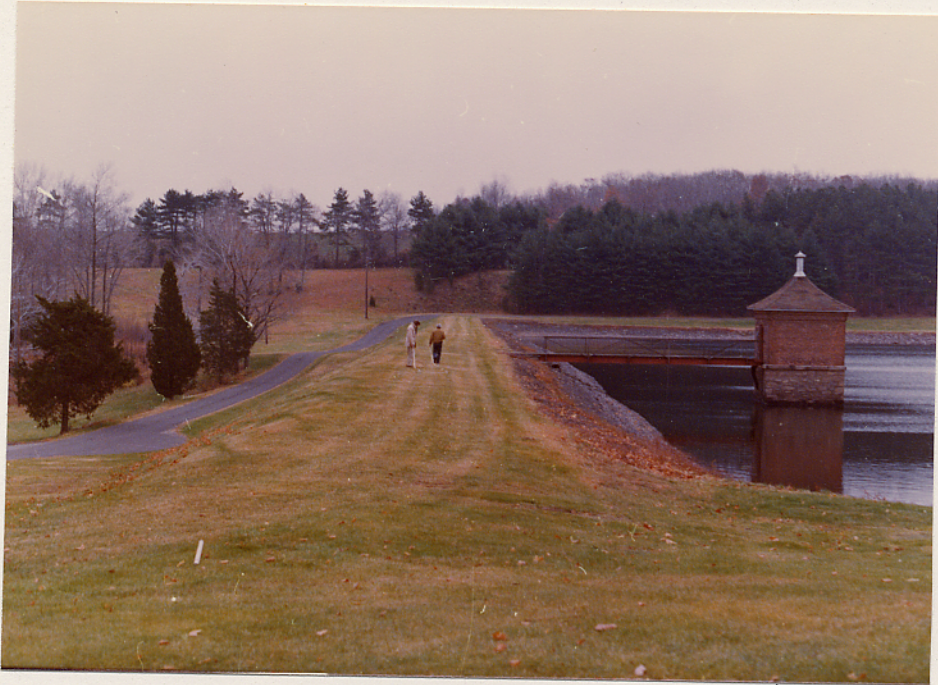
Overview from left abutment

The gatehouse is a brick structure approximately 10 ft. square surmounting a masonry outlet tower 36 ft. high, and is in good condition. Access to the gatehouse is provided via a steel catwalk from the crest of the dam (Overview Photo).

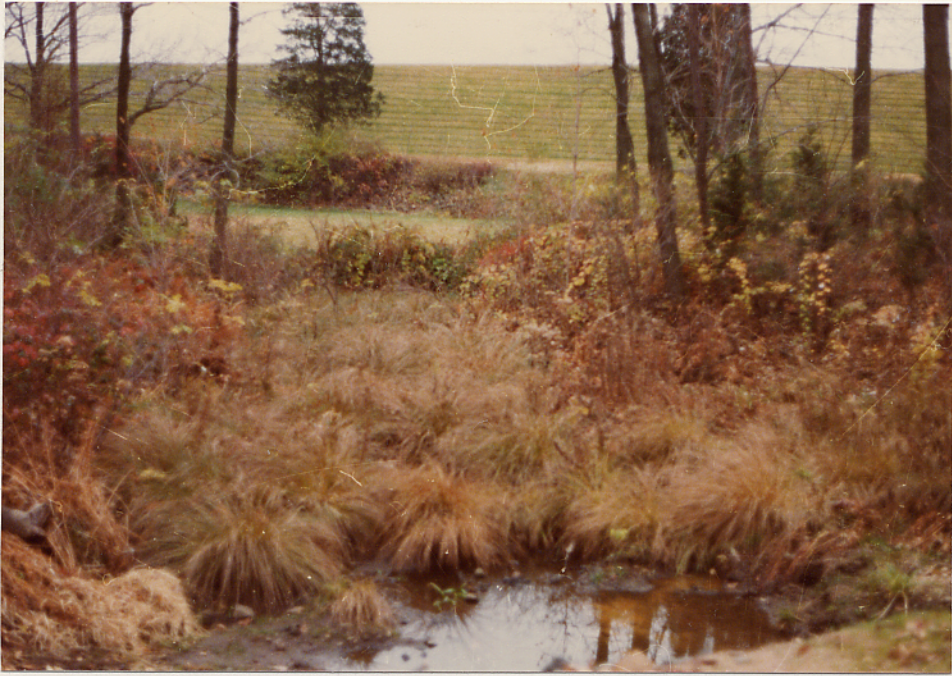
Marshy area to right of outlet channel below dam  
and trail possibly caused by seepage.

1. Marsh opposite right center of dam, looking upstream.

It is recommended that the owner should retain the services of a competent registered professional engineer to make further investigations of the flows in the outlet channel and the causes of the two marshy areas below the dam. These investigations should be carried out during a period of high reservoir level. If proved necessary, suitable remedial works should then be designed and implemented to correct any deficiencies revealed by the investigations.

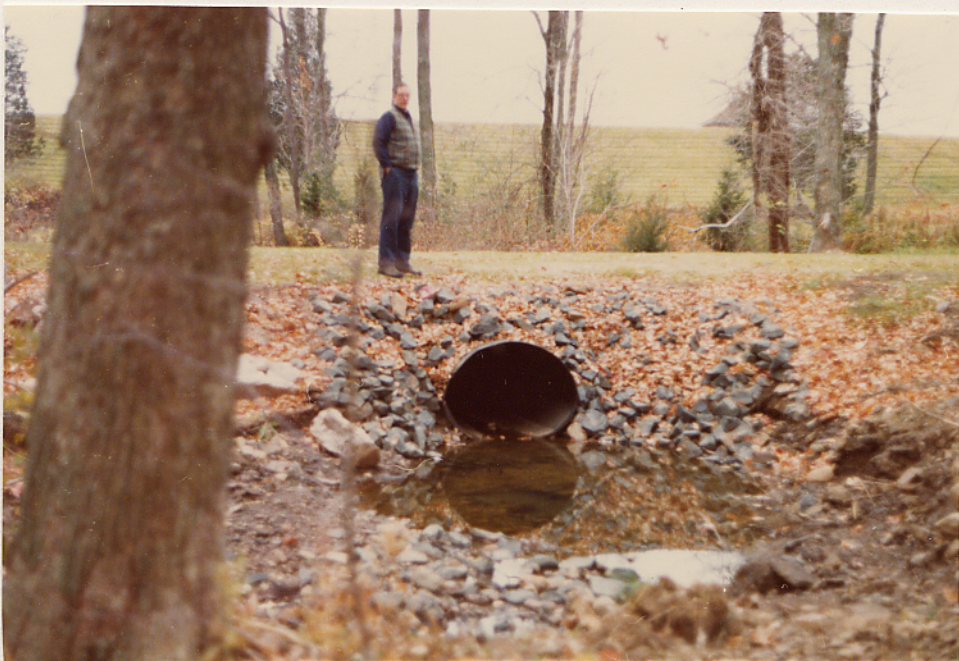
2. Outlet channel culvert under trail below dam.

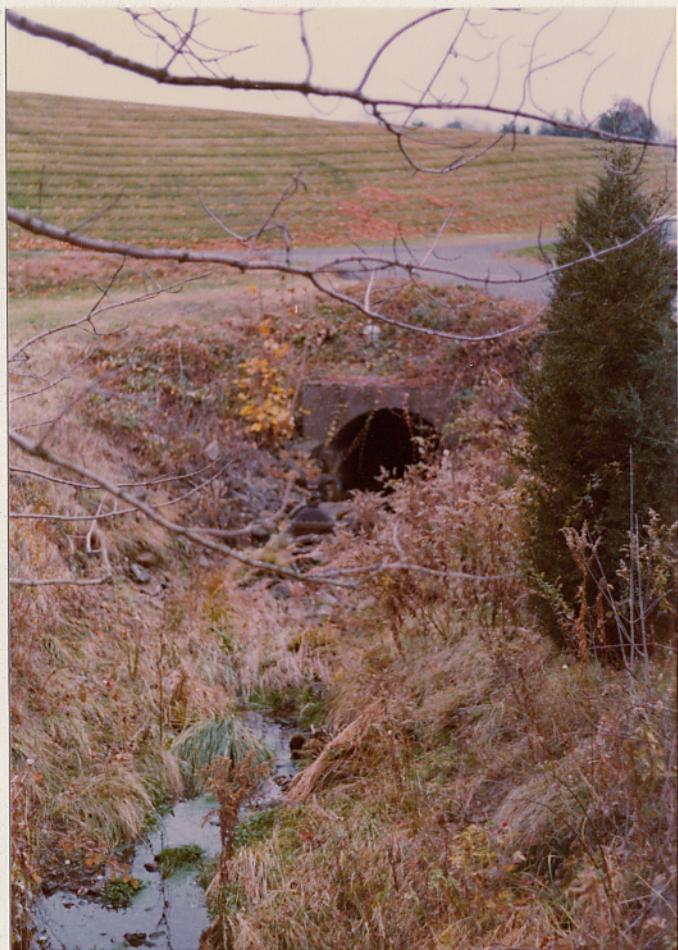
3. Headwall on 36 in. dia. outlet pipe.

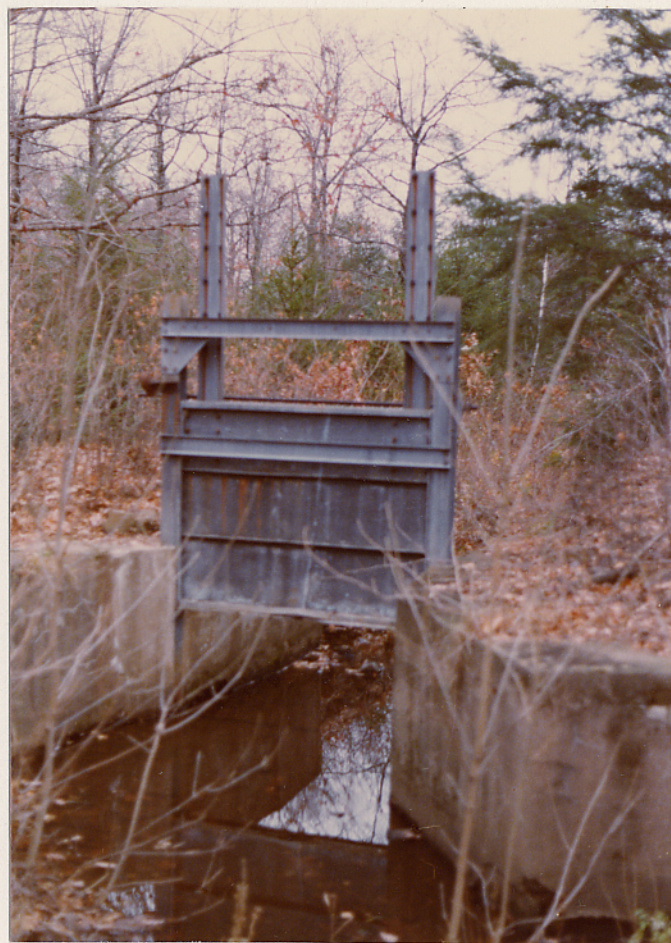
4. Steel slide gate on channel from Adder Reservoir.

3. The 12 in. dia. supplementary inlet pipe control valve should be checked for operability.
4. The unserviceable steel slide gate which controls inflows from Adder Reservoir should be repaired.

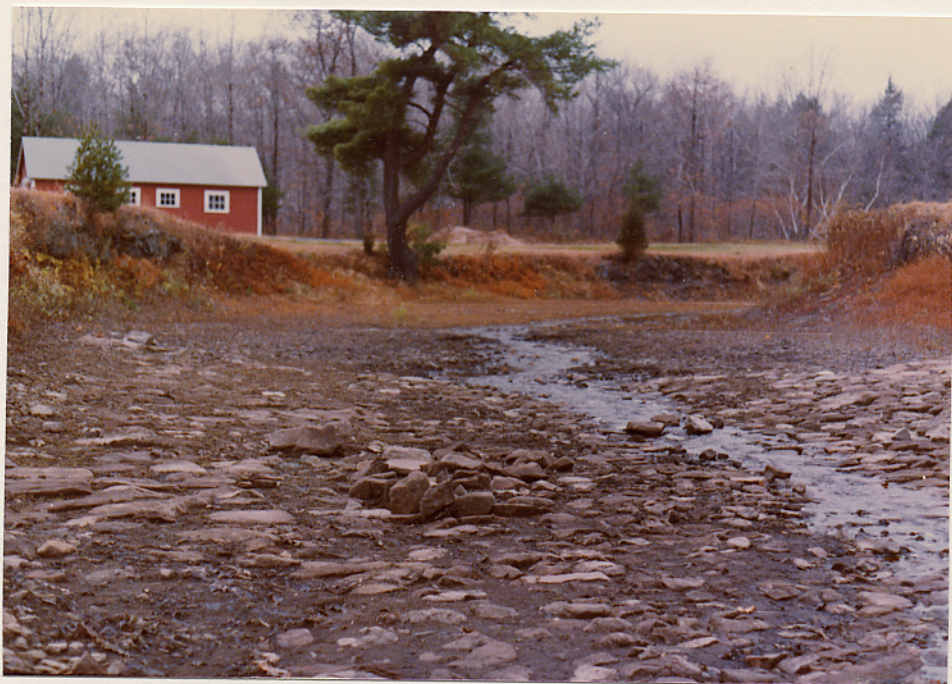
The spillway channel is unlined. The first 150 ft. is riprapped and the remainder is in rock cut, which appears to be stable. Some brush growth has established itself in the channel, which might best be grubbed out (Appendix C, Photo Nos. 5 & 6). The riprap at the beginning of the spillway channel appears to be in good condition. The twin masonry arch bridge across the channel requires some grouting but otherwise is in good condition (Appendix C, Photo No. 7). The concrete spillway sill is 2 ft. high, in good condition, and the discharge channel is paved with asphalt for about 50 ft.

5. Spillway approach channel

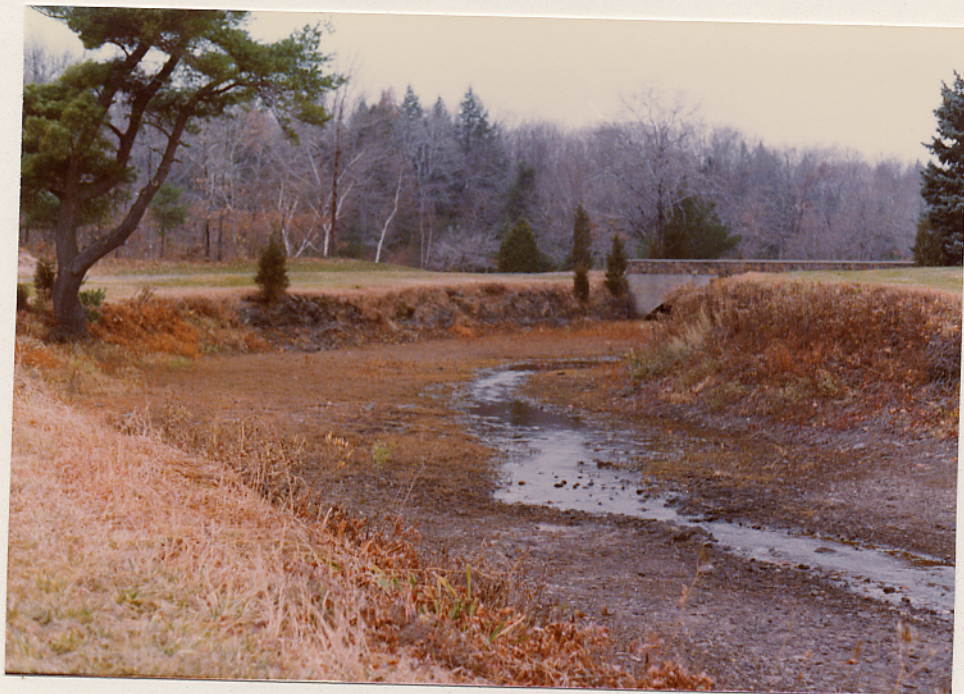
6. Spillway approach channel

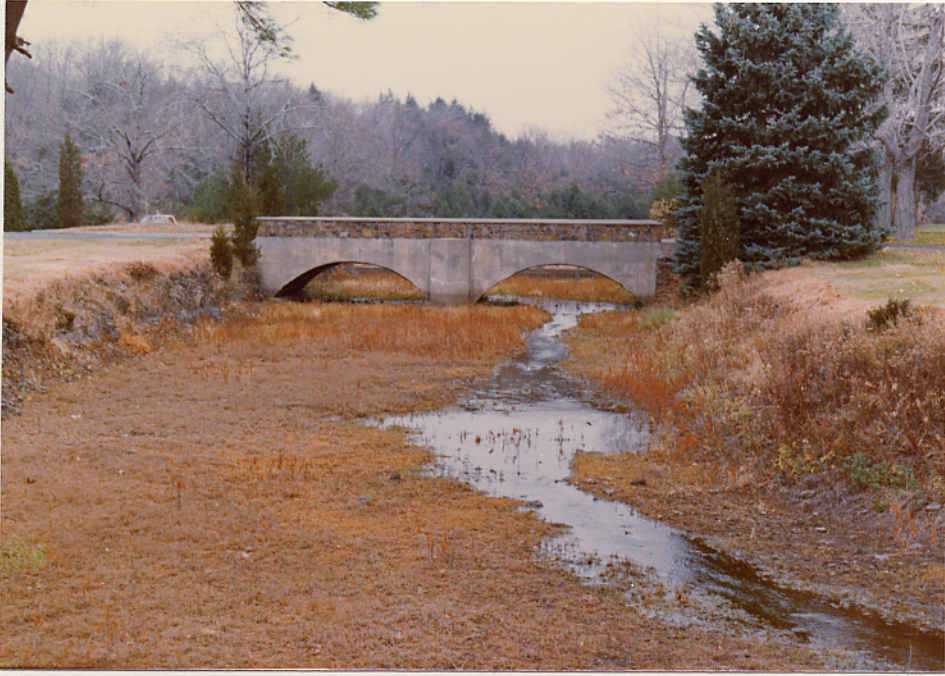
7. Twin arch culvert carrying access road across spillway approach channel

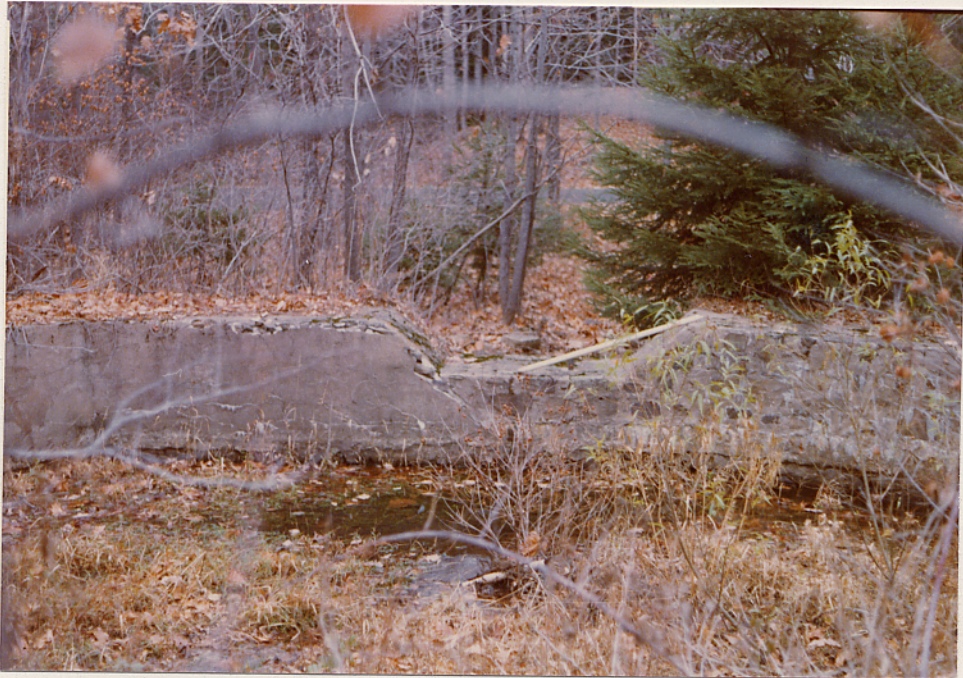
8. Trapezoidal notch for diverting inflows from Adder Reservoir
